# FARMERS' BULLETIN

759

## "WHITE ANTS"<sup>1</sup> AS PESTS IN THE UNITED STATES AND METHODS OF PREVENTING THEIR DAMAGE.

By T. E. SNYDER,

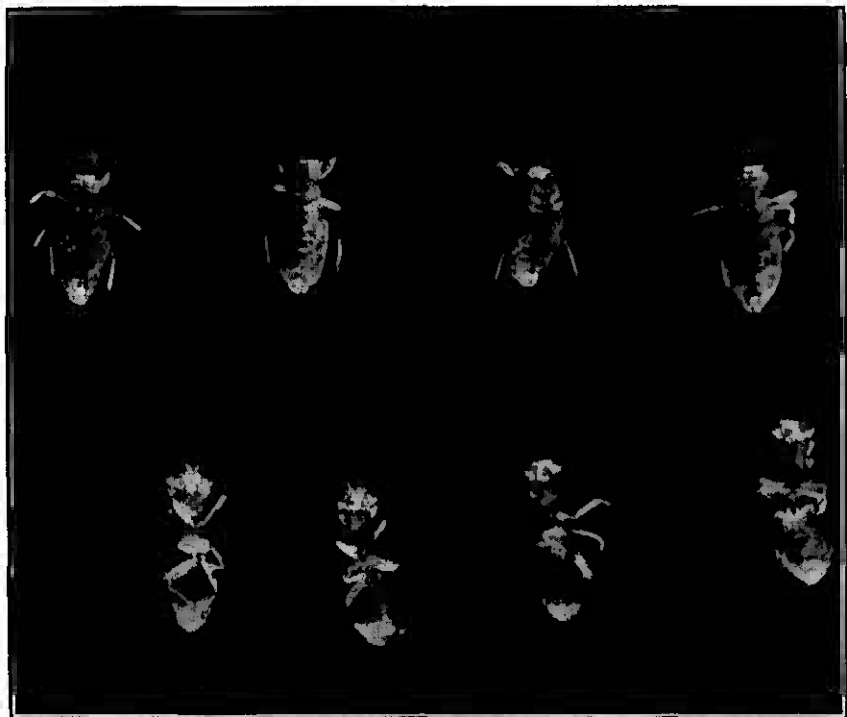
FIG. 2.—Mature "workers" of the white ant known as *Leucotermes flavipes*; etherized specimens. Enlarged nearly six times. (Original.)

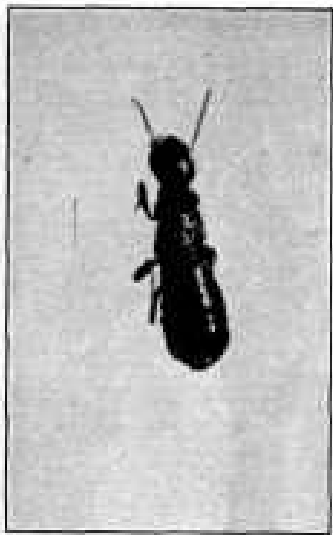
FIG. 4.—Mature "king" of normal form of the white ant known as *Leucotermes flavipes*; several years of age. Etherized specimen, enlarged six times. (Author's illustration.)

numerous forms permanently present in the colony. Other forms in the colony are the reproductive individuals; in some colonies these consist of a single pair, the normal king (fig. 4) and queen (fig. 5), while in other colonies many supplementary nymphal (fig. 6) or larval types may be present. These reproductive forms never reach the size attained by those of certain species of termites in the Tropics and never lose the power of movement.

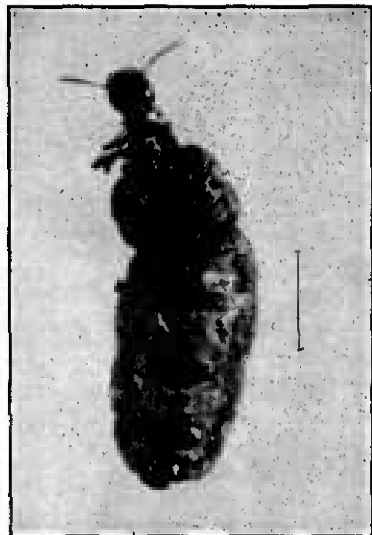
FIG. 5.—True "queen" of the white ant *Leucotermes flavipes*, with wing stubs and chestnut-colored hard parts. Etherized specimen, enlarged six times. (Author's illustration.)

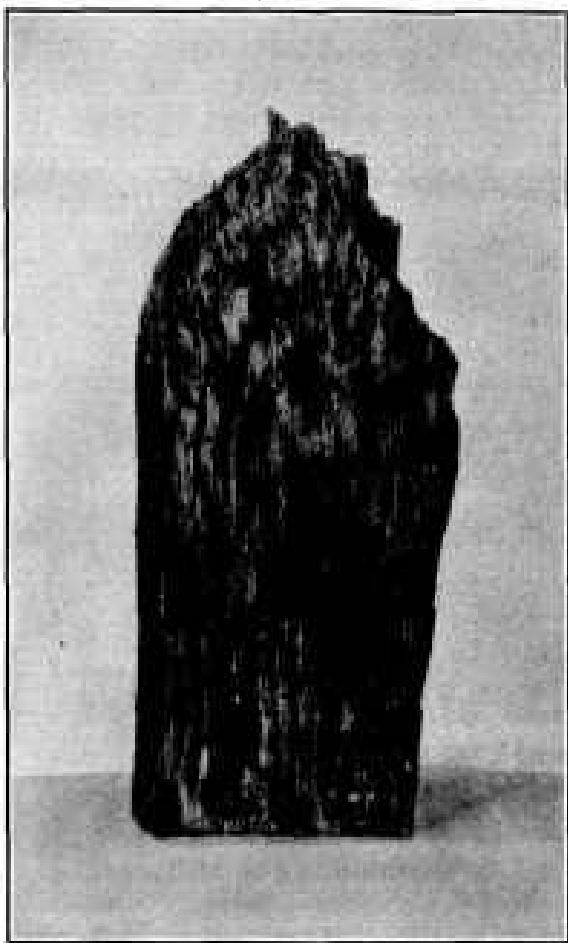
FIG. 9.—Work of a large western white ant, *Termopsis angusticollis*, in western yellow pine. Placerville, Cal. (Original.)

<sup>1</sup> In California damage to poles by *Termopsis angusticollis* Walker (fig. 9), and in the Gulf States by *Culotermes* spp. also occurs.

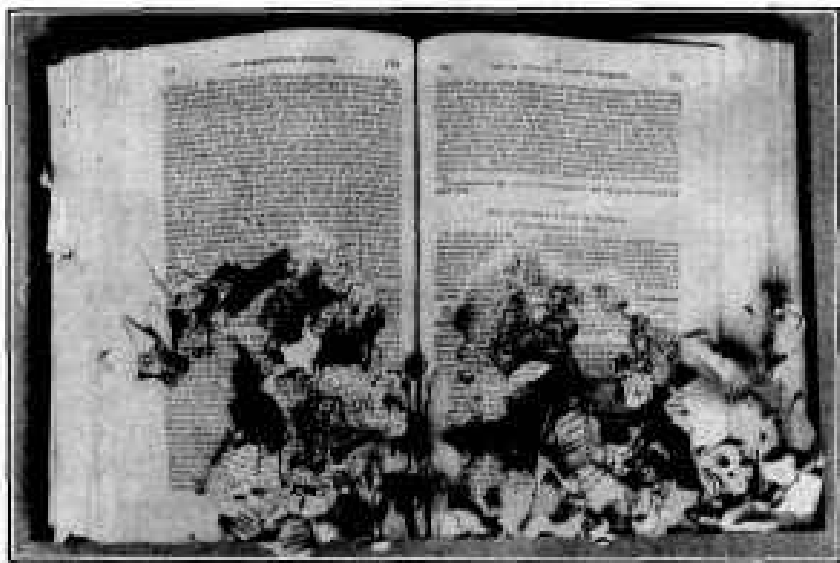
FIG. 10.—Book from library at Van Buren, Ark., ruined by white ants. June, 1915. (Author's illustration.)

Of the stored material sometimes seriously injured or destroyed by termites may be mentioned wooden electrotype blocks and other wood products, books or papers in libraries or elsewhere (fig. 10), valuable documents (fig. 11), wood-pulp products, pasteboard, rolls of cloth and other fabrics, clothing, shoes and other leather products, as well as food stored on shelves or on the floors in dark, damp basements or cellars, or similar moist places where the ventilation is poor.

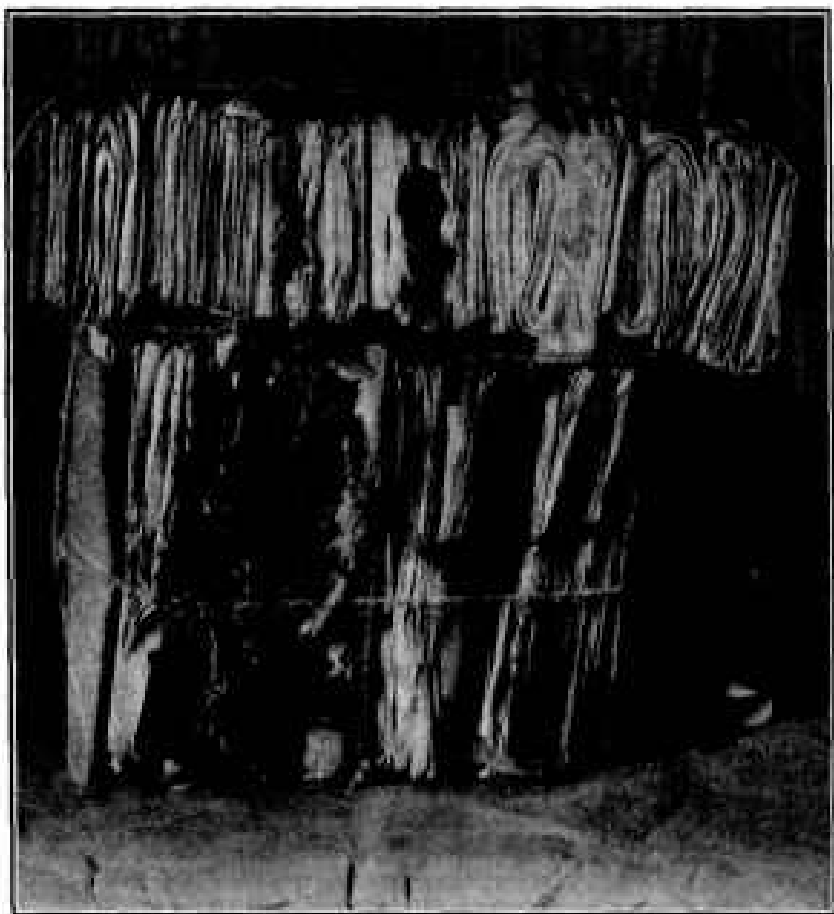
FIG. 11.—Damage by the white ant *Leucotermes flavipes* to bundles of old documents stored on tiers of wooden shelves standing on pine flooring in heated, damp, dark basement of an old building in Washington, D. C. Note how an earthlike mixture of moist earth and finely digested, excreted wood is carried into the mines of the insects in the bundles. If the connections of the termites with the ground or decayed wood, their source of moisture, be shut off, the insects perish. (Original.)

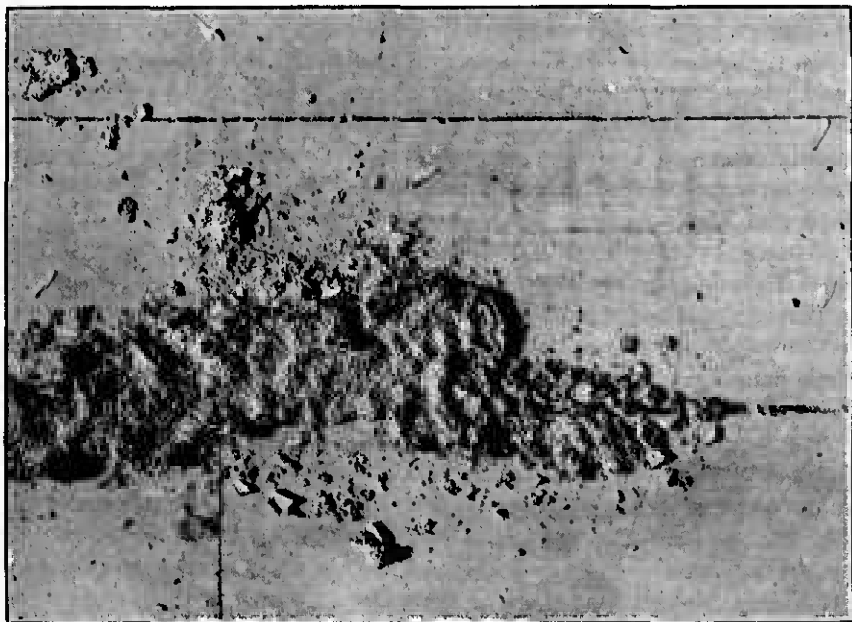
FIG. 13.—Earthlike shelter of the white ant *Leucotermes flavipes*, built on pine flooring in heated, damp, dark basement. The worker termites have come up through cracks between boards of the infested floor and made craterlike openings for the emergence of the winged, sexed adults. Note the shed wings on the floor. The swarm occurred February 14, 1916, in an old building in Washington, D. C. (Original.)

Another warning of the presence of termite infestation is branching shelter tubes of small diameter, constructed of earth mixed with finely comminuted wood, on foundation timbers or other weedwork (fig. 13), or over the surface of stone, brick, or other impenetrable foundation material (fig. 14) from the ground to the woodwork. Drenching the ground where these tubes originate with kerosene oil will afford relief.

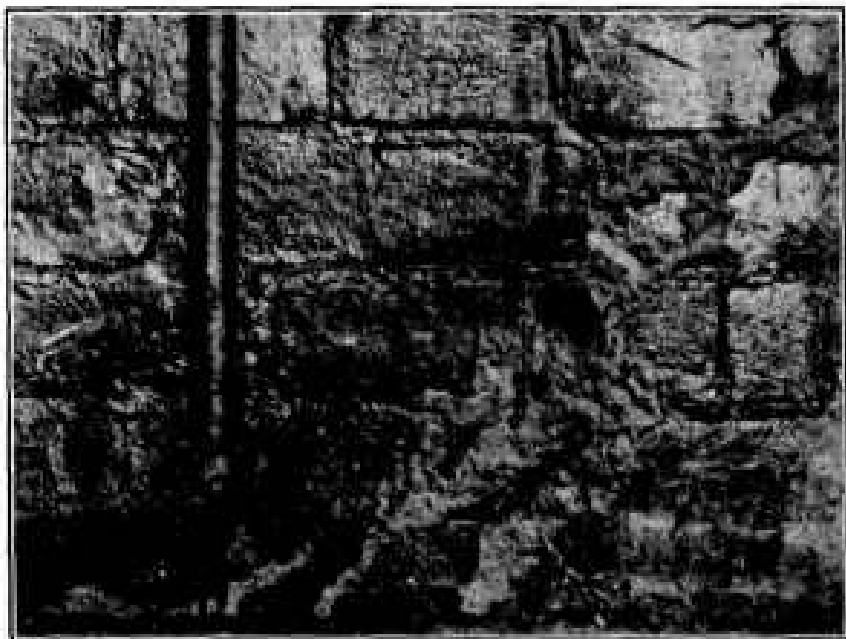
FIG. 14.—Earthlike shelter tubes of the white ant *Leucoterme flavipes*, constructed of earth mixed with finely digested, excreted wood, and built over brick wall in heated, dark, damp basement. These tubes extend through cracks between the basement pine flooring and the wall near a steam radiator. Note the granular structure. The insects use these tubes in passing over impenetrable substances and to protect them from the light in extending their galleries—in this case up to the next floor in an old building in Washington, D. C. (Original.)
